**Thru Tubing Solutions' Abrasive Cutting System Performs Cut on Stuck 4.50" OD Drill Pipe in Horizontal Section, Saving Customer Rig Time And Money.**

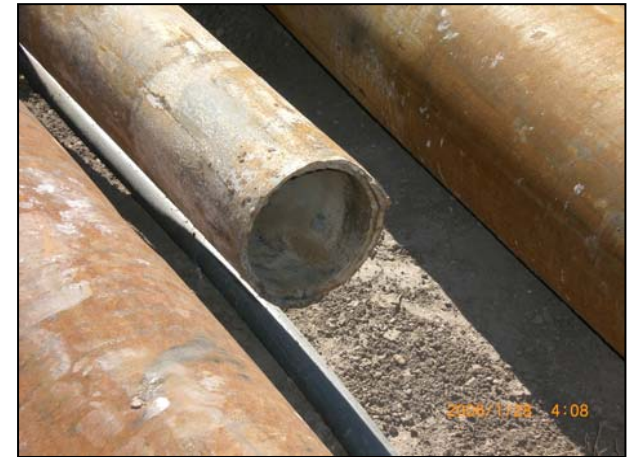
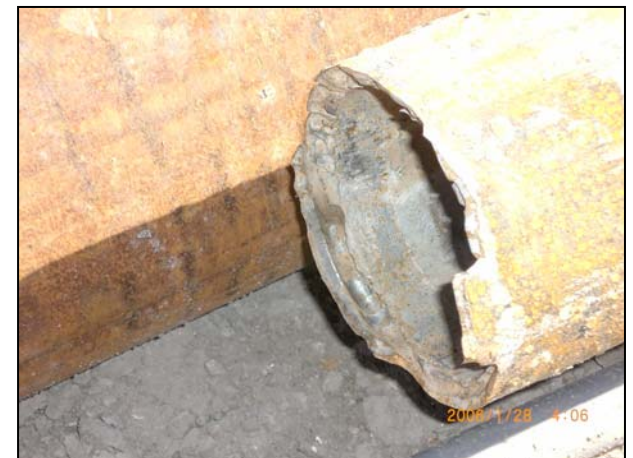
The drill pipe was cut cleanly, allowing the fishing string to latch the subsequent fish without dressing the top of the drill pipe.

TTS was able to cut the drill pipe in the horizontal section, where conventional attempts had failed. The drill pipe was compromised cleanly, negating the necessity of dressing of the fish and allowing the fishing tools to easily latch the fish. This helped the rig retrieve the fish in a more timely manner, saving the customer valuable rig time.
